Quick Assessment of the Navy Mark V CBR Respirator After 13 Years in Storage

ARL-TR-3069

September 2003

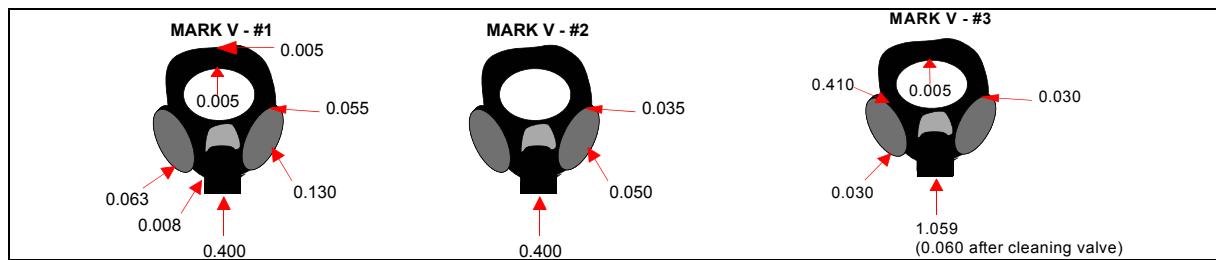
Figure 3. Leak locations and percent penetration in the Mark V respirators.

Figure 3 illustrates the locations where leaks were found in three Mark V respirators using the face-form leakage detector. In mask no. 1, leaks were found at the top of the face seal, at the top of the lens where the lens meets the mask, at the bottom of the face seal, at the exhalation valve, and at various spots around the canister-mask connection. Mask nos. 2 and 3 also showed leaks at the exhalation valve and around the rubber mounting/sealing gasket of the filter canisters, and mask no. 3 showed an additional leak at the top of the lens.

This part of the fit factor testing pinpointed where the problem areas of the mask were. The human testing conducted under the hood showed the cumulative effect of all the leaks in each mask. Table 3 compares the test results of each mask conducted on a single human subject. The fit factor numbers were converted from the raw concentrations of aerosol displayed by the TDA 99D. The averages shown in Table 3 represent the geometric mean of the values of the nine exercises when each mask was worn. Mask no. 2 had a geometric mean of 0 because exercises 4 and 6 had a reading of 0.

The physiological problems of the mask become irrelevant when one sees the results of the fit factor tests. According to these results, the wearer of this mask in a toxic environment would probably be incapacitated before he or she had to worry about vision or prolonged exercise. The current U.S. Army requirement is a fit factor of 1667 as a minimum standard for gas masks (King, 1983). The Mark V respirator did not meet this standard even during quiet breathing. The primary problem areas of the mask appear to be the exhalation valve and the canister connections. Rather than using threaded filter canisters, the Mark V respirator uses filter canisters that are held to a mounting plate by an attached rollable rubber mounting/sealing gasket. When these rubber gaskets are relatively new, they may provide adequate protection against leakage. However, as the gaskets get older, as seen by all three sets of filter canisters used in this evaluation, they could crack and leak. The problem with the exhalation valve could be due to one or more of several reasons: (a) loss of stiffness with age allowing the valve to prolapse, (b) turbulent backflow or, (c) a simple design flaw.

The face seal of the mask, by itself, appeared to be adequately functional when tested on the faceplate of the TDA 99D mask leakage detector, but this seal could very well have been broken by the various head movements performed during the dynamic human fit factor test. Low-level leakage at the top-center of the face piece, top center of the lens, and bottom center of the face piece in mask no. 1 suggested that a compression set had begun because it was folded during storage. When the three masks evaluated were removed from their original packaging at the beginning of this study, they were mounted on a stiff cardboard three-dimensional (3-D) frame in their carrier bags to prevent compression set during storage. This storage frame had a wide, flat central surface to preclude the mask folding in the center and thus should inhibit the compression set. There was no visual indication of the compression set in any of the masks during our initial inspection. The onset of compression set was only suggested in one of the three masks when a leakage test was performed. When the U.S. Navy conducted a survey on Mark V respirators aboard 10 ships (Chambers, 1984), they found 52.2% of the 78 masks surveyed had slight to severe permanent compression set in masks 1–27 years old. Unfortunately, the data presented in Chamber's report did not indicate the ages of the masks showing a compression set, nor did they indicate if they were mounted on the 3-D frame in their carrier.

Overall, the results of this study indicate that the Mark V respirator does not provide sufficient fit factor protection to the user against toxic materials after 13 years in storage; the masks should be discarded or possibly used solely for training purposes when such compromised mask use is appropriate and acceptable. Because the Mark V respirator was designed without a nosecup, CO₂ has a tendency to rapidly accumulate within the mask. This dramatically affects the breathing capability of the wearer and limits his or her ability to work. Visual capability when wearing the mask appears acceptable except that the lower visual field of view is reduced.
